NBSIR 84-2949

Advanced Thin Film Thermocouples

October 1984

Prepared for
National Aeronautics and Space Administration
Lewis Research Center
Cleveland, OH 44135

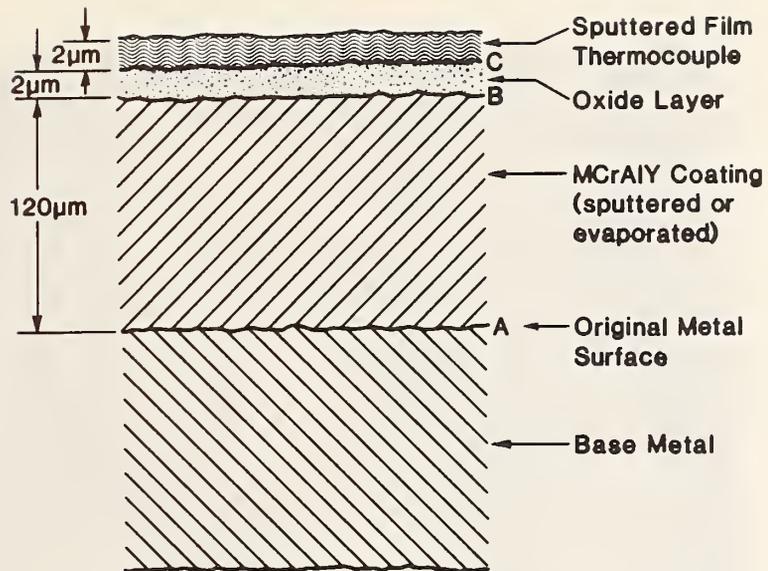
Figure 1. Schematic cross section of thin film sensor

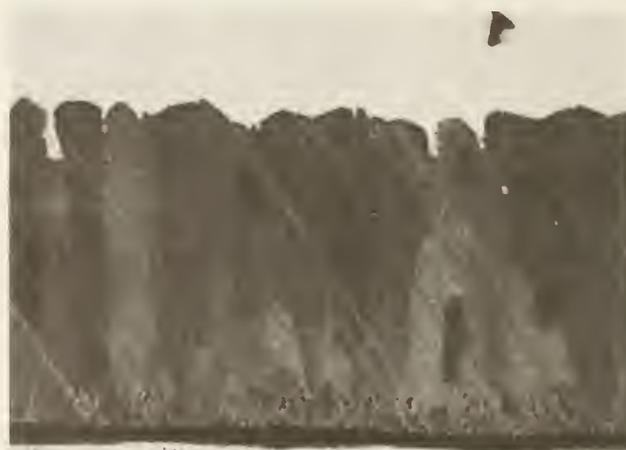
Figure 4. Sputtered FeCrAlY coating on Ni alloy Ni backing on top. Notice faceted growth (1000x)

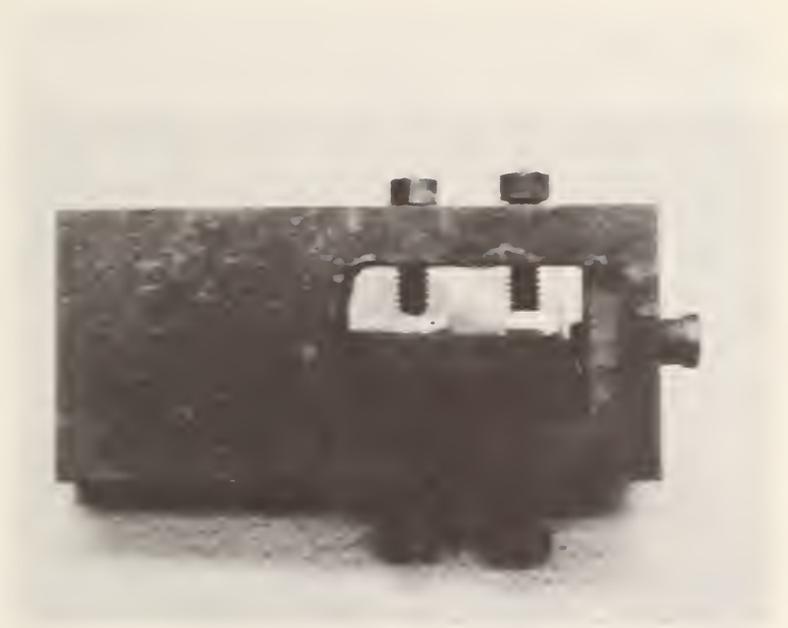
Figure 5. High temperature electrical test fixture

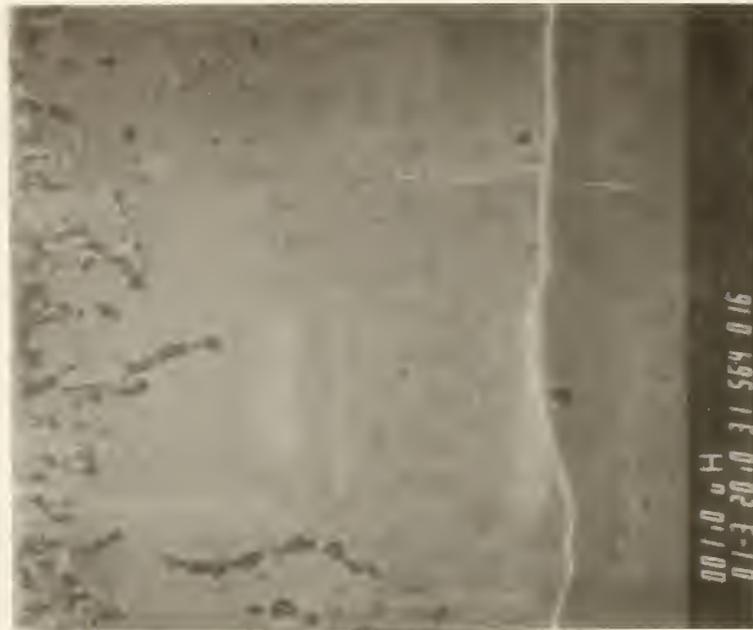
Figure 7. Scanning electron micrograph of D4 (1530x)
Oxides are penetrating inward from surface
Heat treated at 1090°C for 50 hours

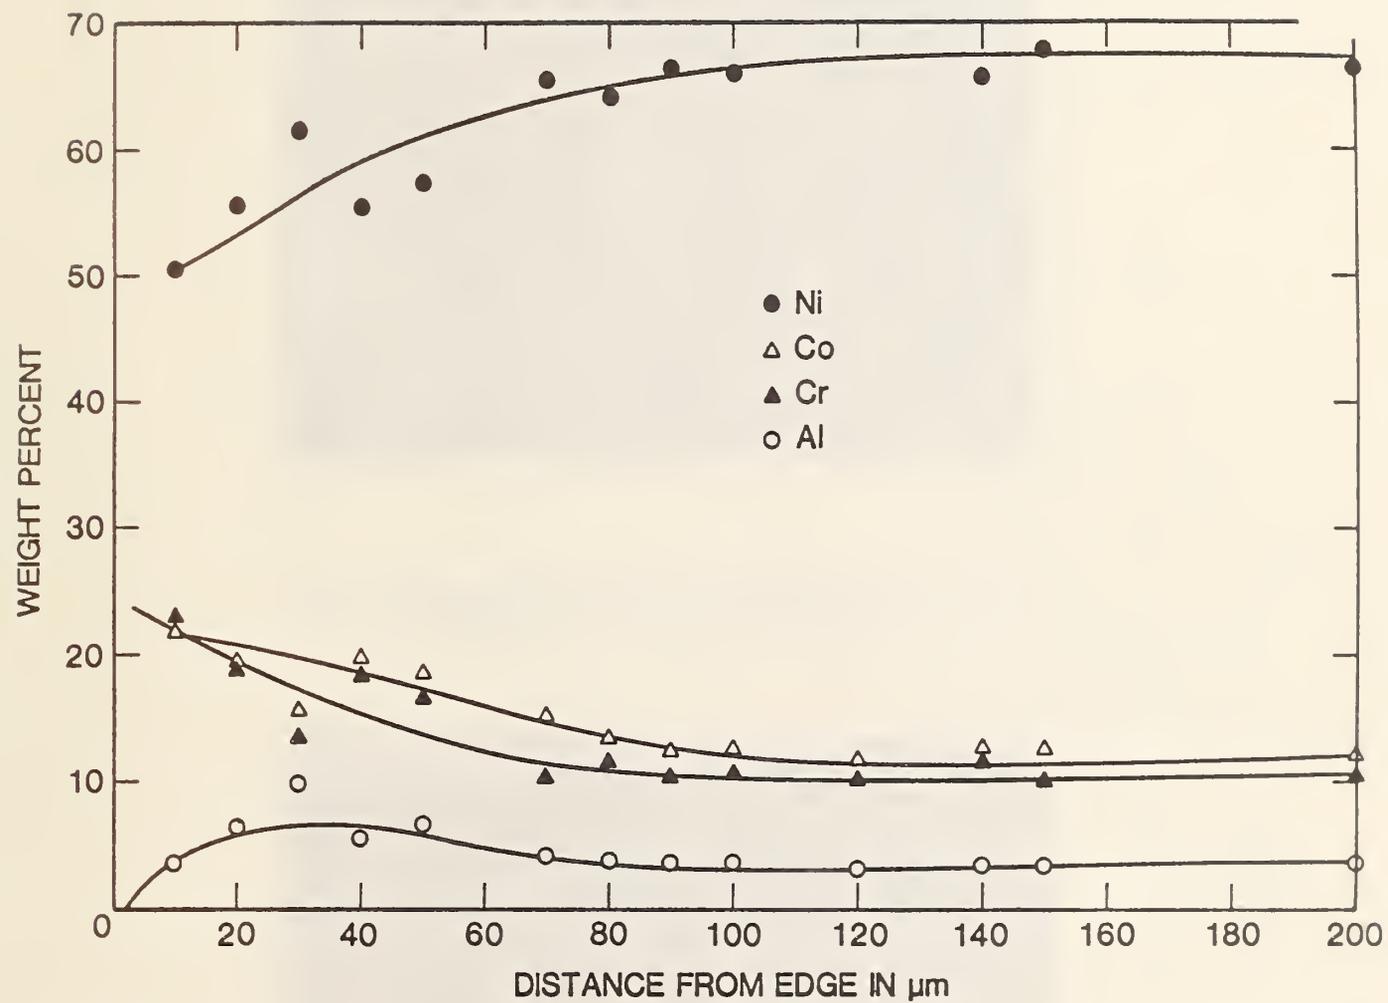
Figure 9. Diffusion profiles of D4
Heat treated at 1090 for 50 hrs without barrier

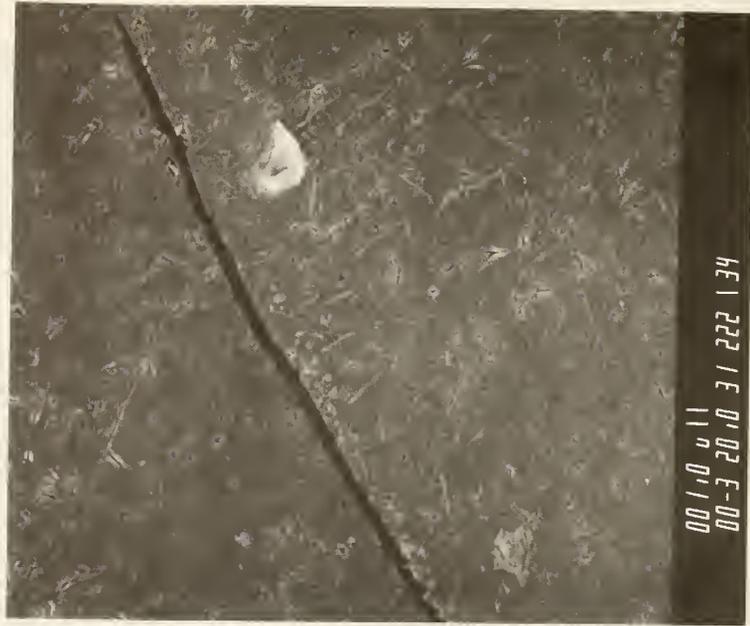
Figure 10. Scanning electron photograph of D14
 Al_2O_3 is dark 1 μm line 580x

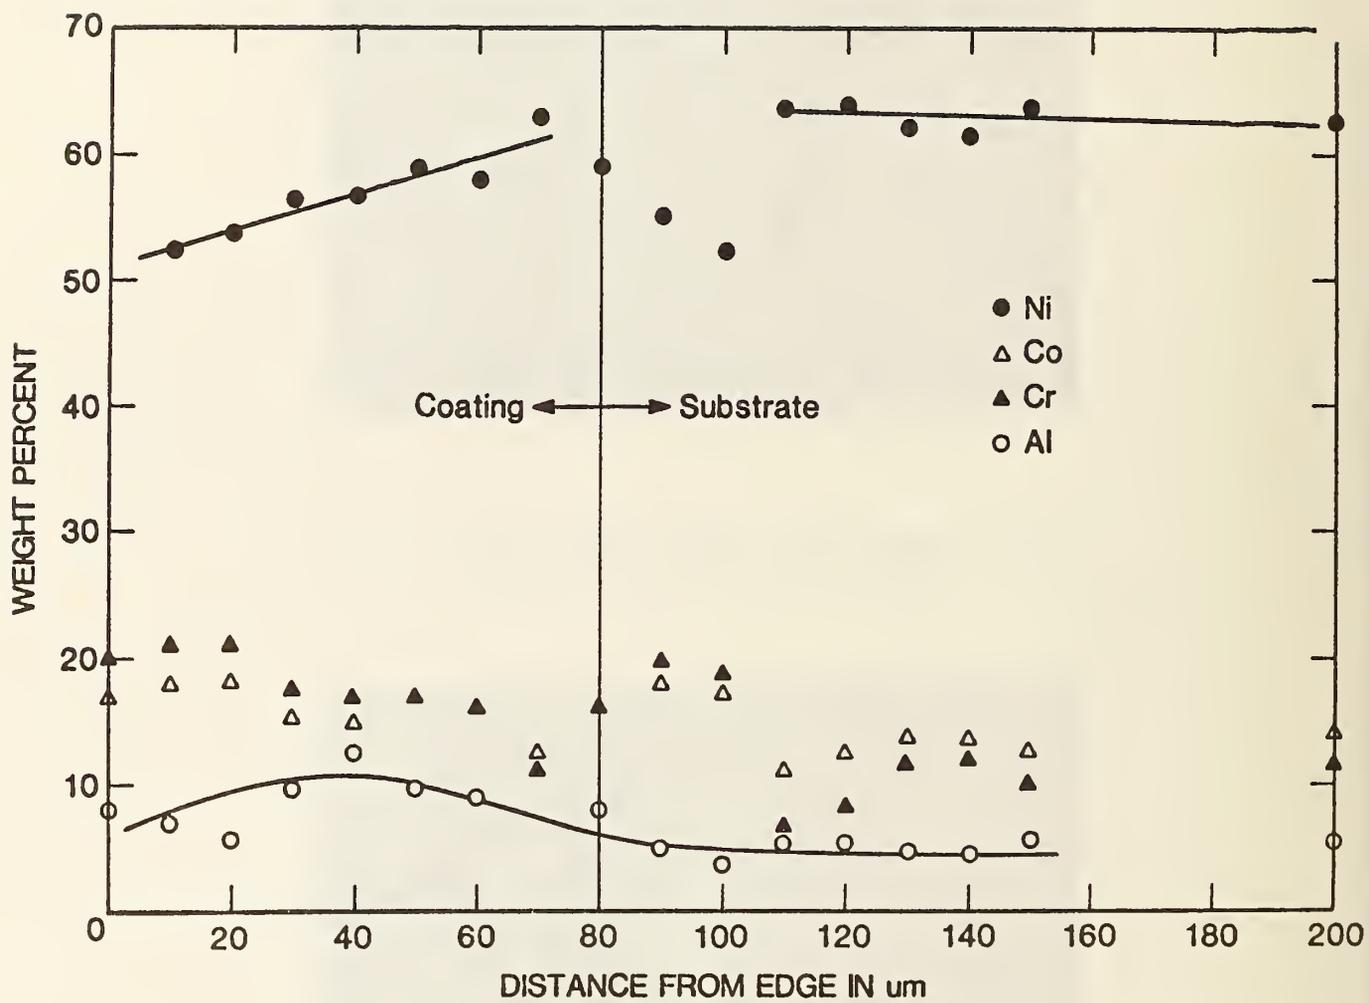
Figure 14. Diffusion profiles of D14.
 1 μm barrier layer 1080°C, 50 hrs

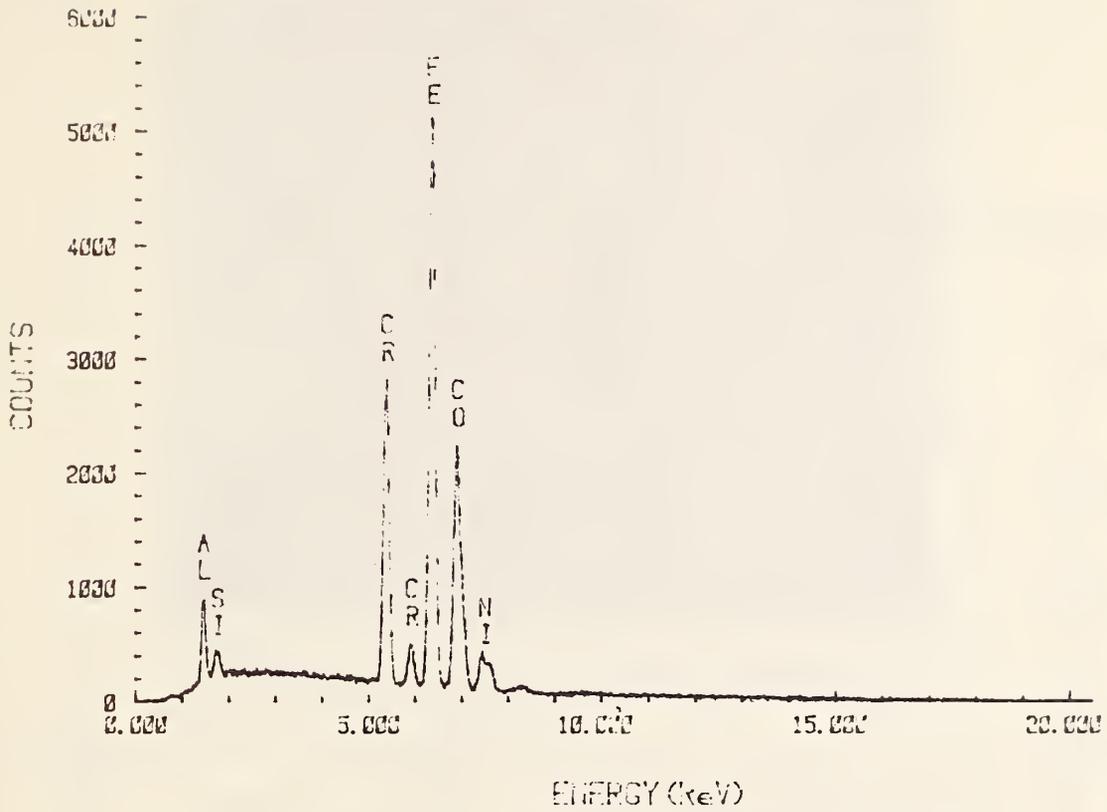
Figure 15. EDX intensity vs. energy of A40 in coating

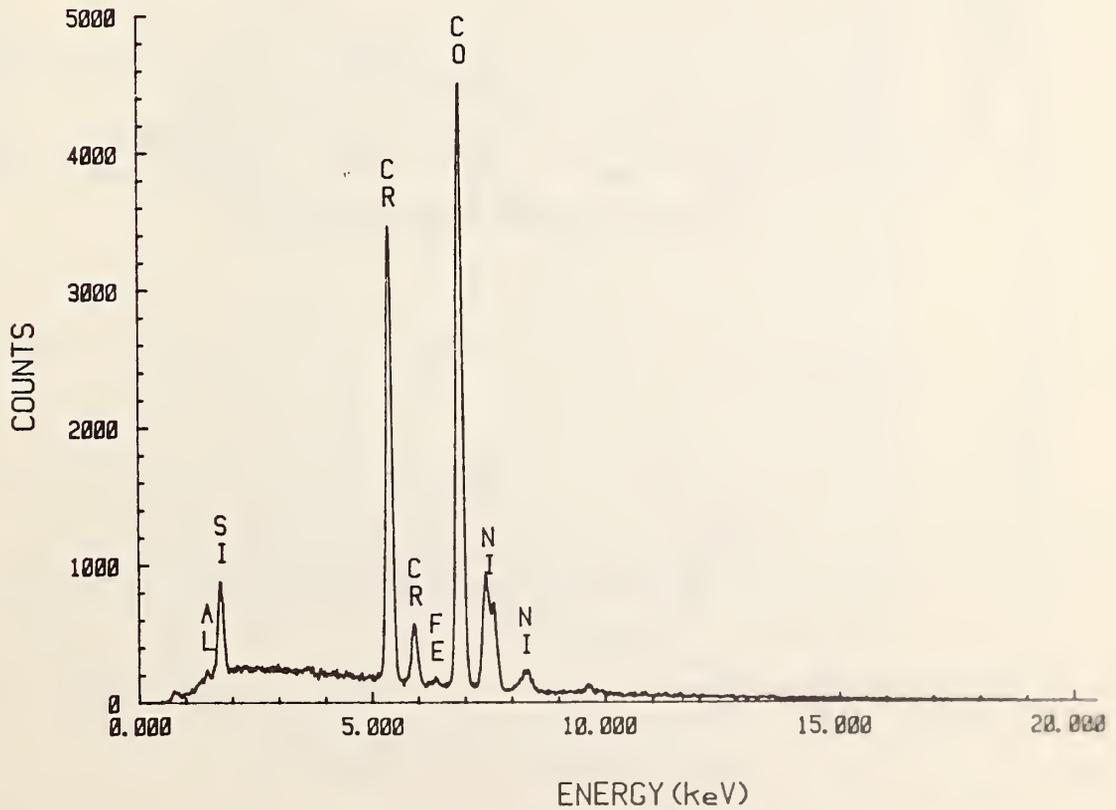
Figure 16. EDX intensity vs. energy of A40 in substrate material

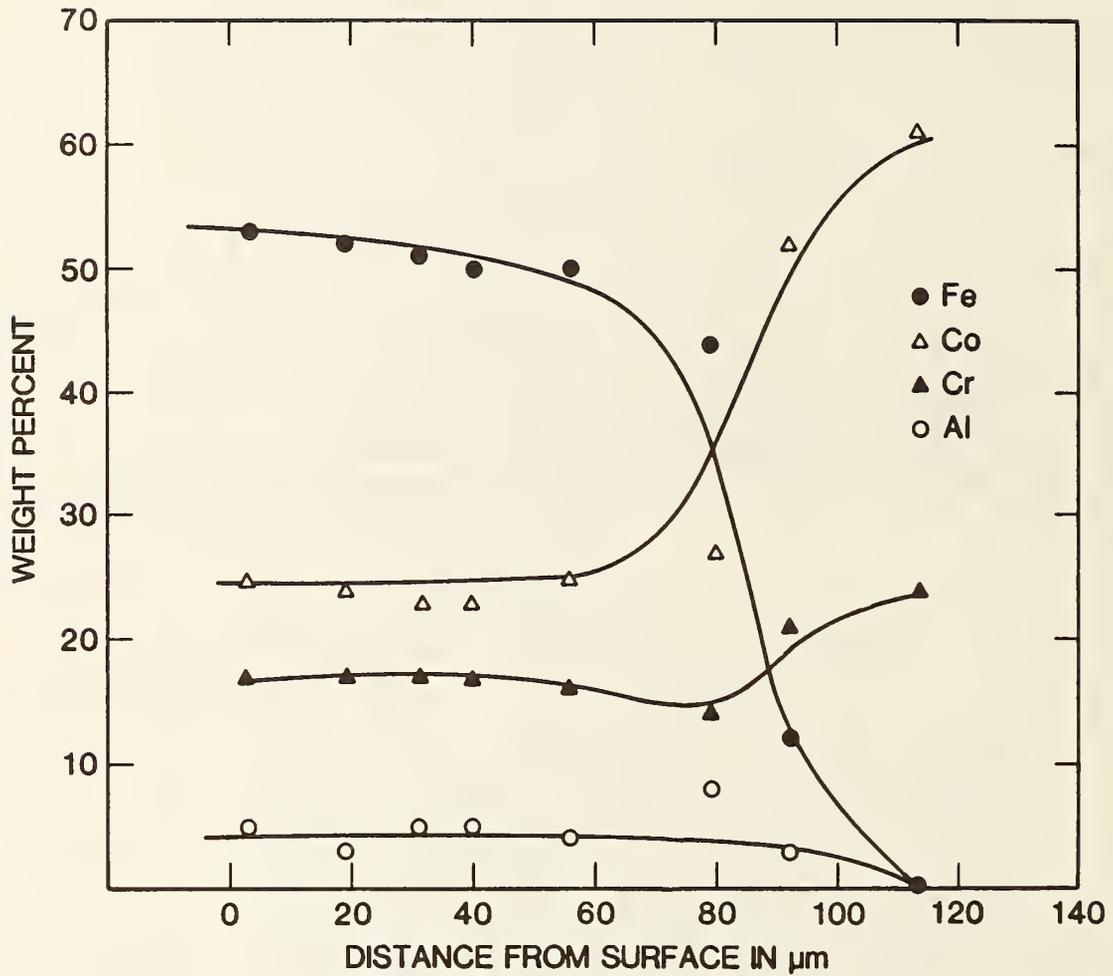
Figure 17. Diffusion profiles of A40
 No barrier layer, 1075°C, 50 hrs

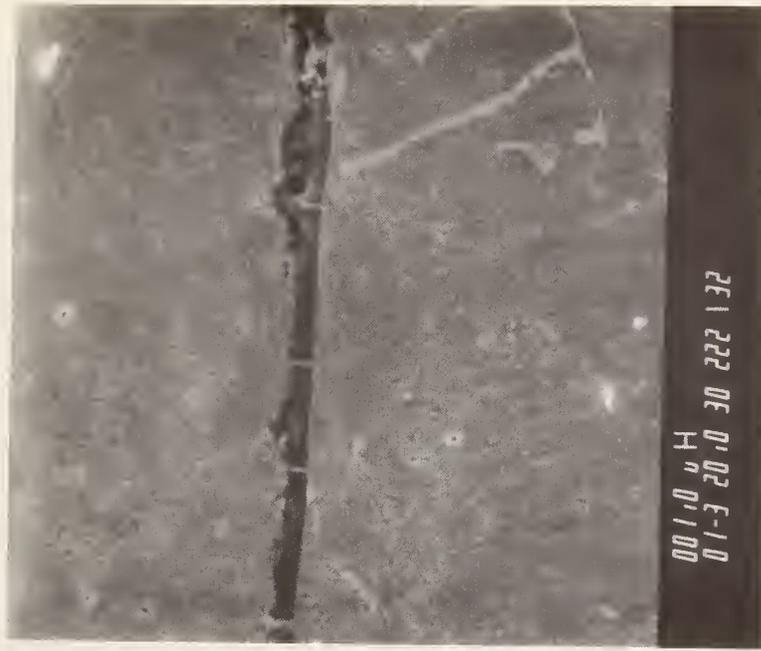
Figure 18. Scanning Electron Micrograph of A19
 Note bridging of Al_2O_3 barrier layer with metal

that is, if the iron and aluminum penetration are not significantly less the barrier coating is not working. A scanning electron micrograph is presented in Fig. 18. The photograph at 1000X indicates some damage to the FeCrAlY coating at the interface, but perhaps more significantly it appears that metal bridges are formed through the Al₂O₃ barrier layer. The diffusion data is presented in Table 8 and a second profile in Table 9. The data from Table 8 are also presented in Fig. 19. Again, the cobalt is rapidly diffusing through the FeCrAlY reaching approximately 25% by weight in the b.c.c. phase. The iron concentration is penetrating at approximately 40 μm to quarter of peak height. This is a greater amount than the diffusion in the A40 coupon which had no barrier. Aluminum penetration to quarter height is also approximately 40 μm. It is clear that the Al₂O₃ barrier is not preventing (or slowing down) diffusion of iron or aluminum into the substrate and it is not slowing down cobalt diffusion into the coating. Chromium is probably not a problem in these alloys. The indications are that the coating is being breached by cracks or holes and the impermeability of the Al₂O₃ for Al, Fe, and Co is not being utilized. Perhaps an improvement of the Al₂O₃ coating technique (for both bonding and continuity) coupled with a rigorous inspection technique could yield a useful barrier layer.

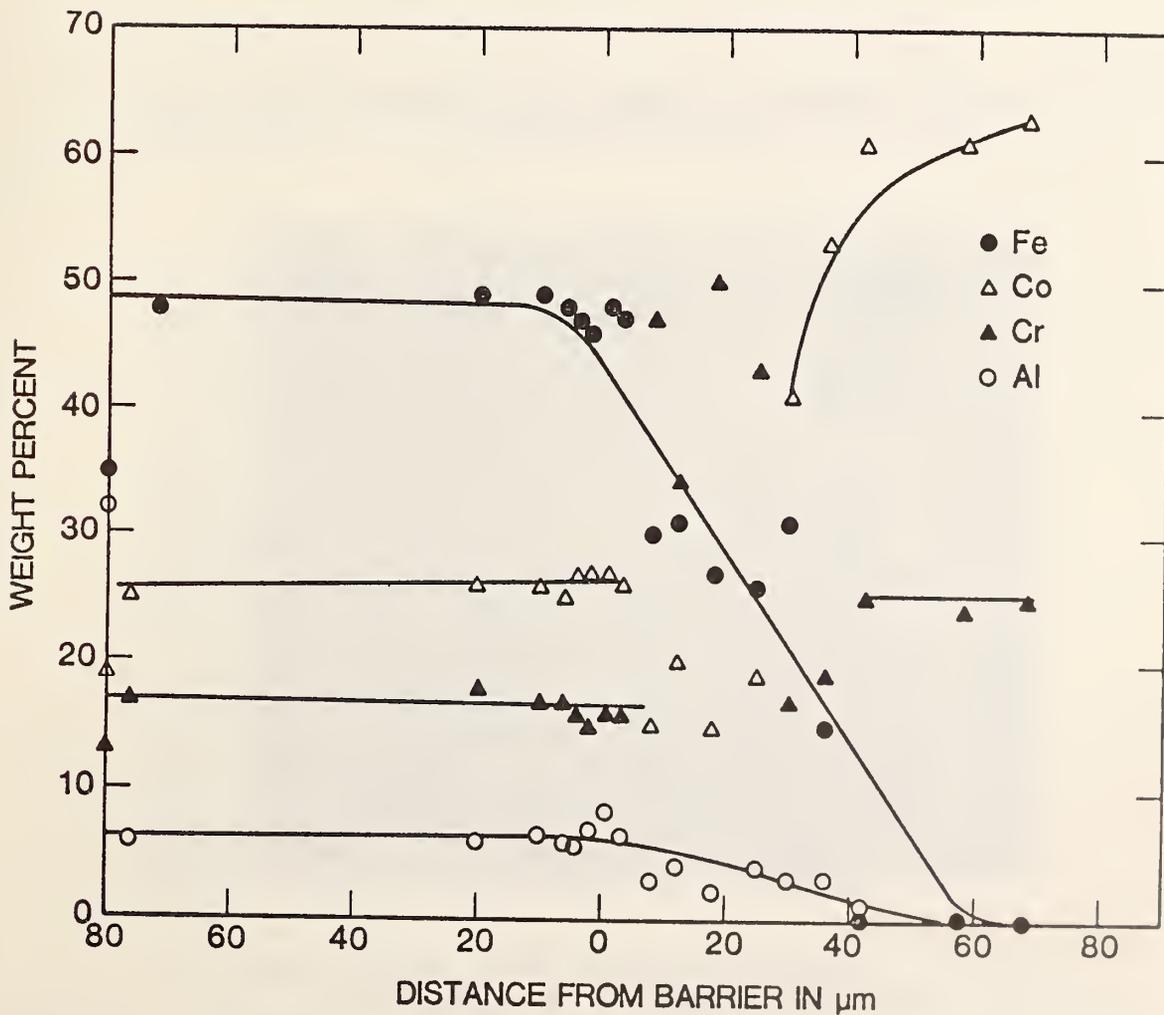
Figure 19. Diffusion profiles of A19
 2 μm barrier, 1075°C, 86 hrs

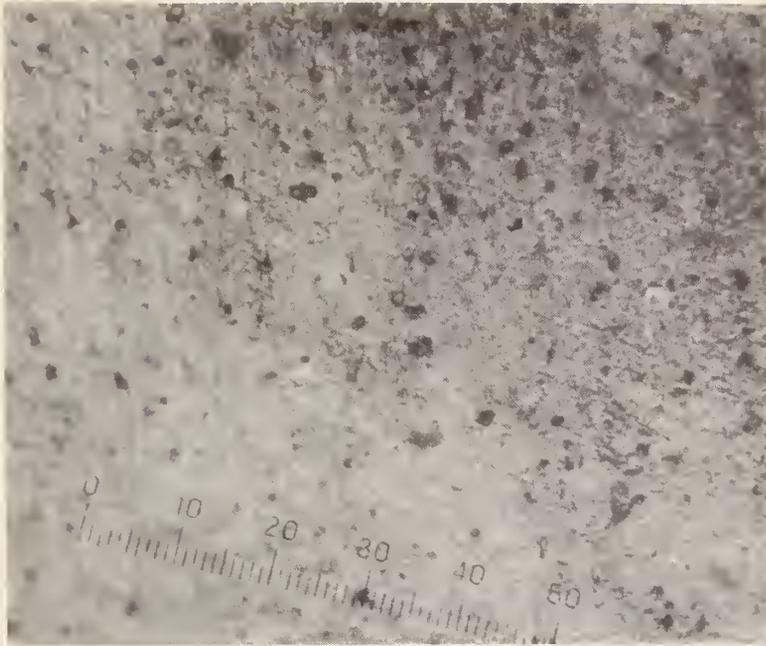
Figure 22. Thermal oxide of FeCrAlY on FeCrAlY on B10
Dark grains are related to uneven growth pattern (500x)

FeCrAlY coatings on MAR M200 + Hf had similar problems and thermal oxide thicknesses are presented in Table 11. Fig. 22 illustrates a second problem on sample B10 which was exposed at 1090°C for 66 hours in an argon plus 4% H₂ atmosphere. Here the Al₂O₃ growth habit is not only in a film but generates "leaders" of more rapidly growing oxide in mounds. The average thickness of this oxide was calculated to be 1.6 μm . Adequate film growth was obtained under the conditions used for sample B41 shown in Fig. 23 (13 hours in dry argon plus 49 hours in air, both at 1070°C). This oxide was 2.1 μm thick.

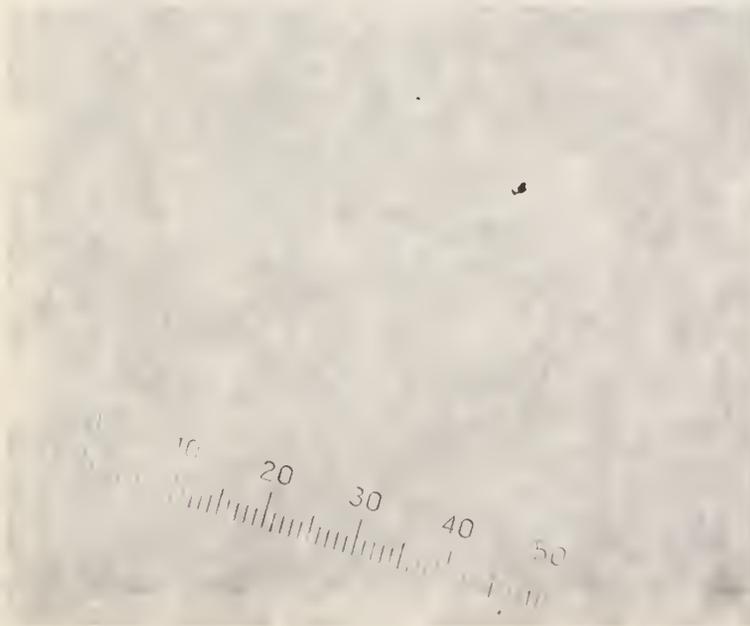
Figure 23. Thermal oxide of FeCrAlY on B41 oxide is 2.0 μm Thick (250x)

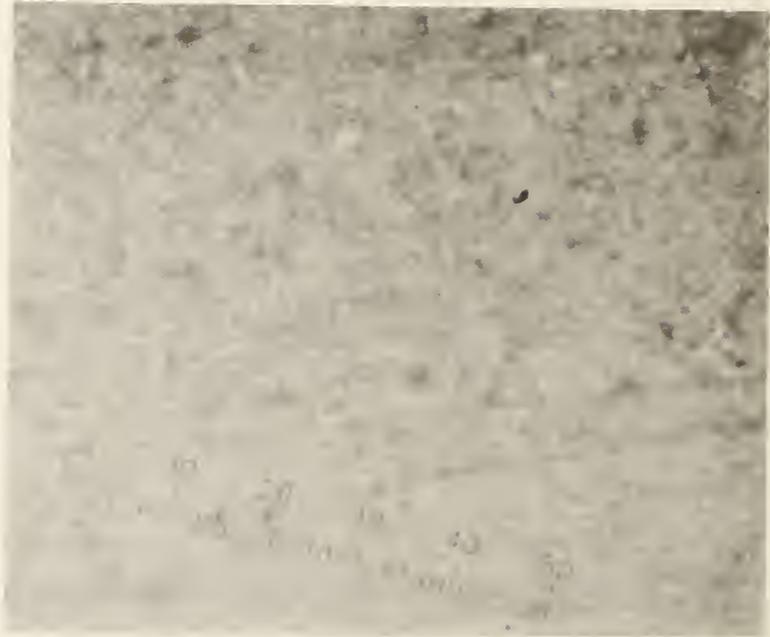
Figure 24. Thermal oxide of electron beam deposited NiCoCrAlY on C21. Small fibrous habit of oxide apparent in addition to film growth (500x)

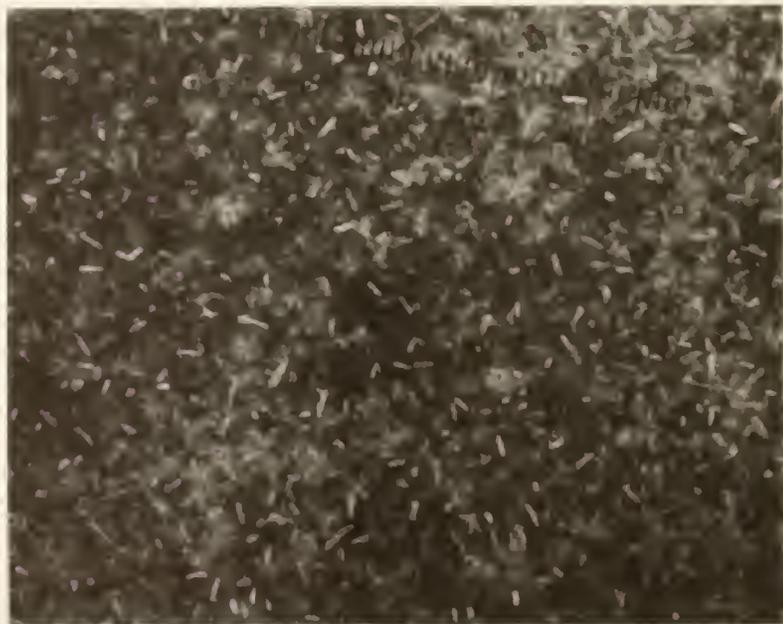
Figure 25. Thermal oxide of sputtered NiCoCrAlY on D8

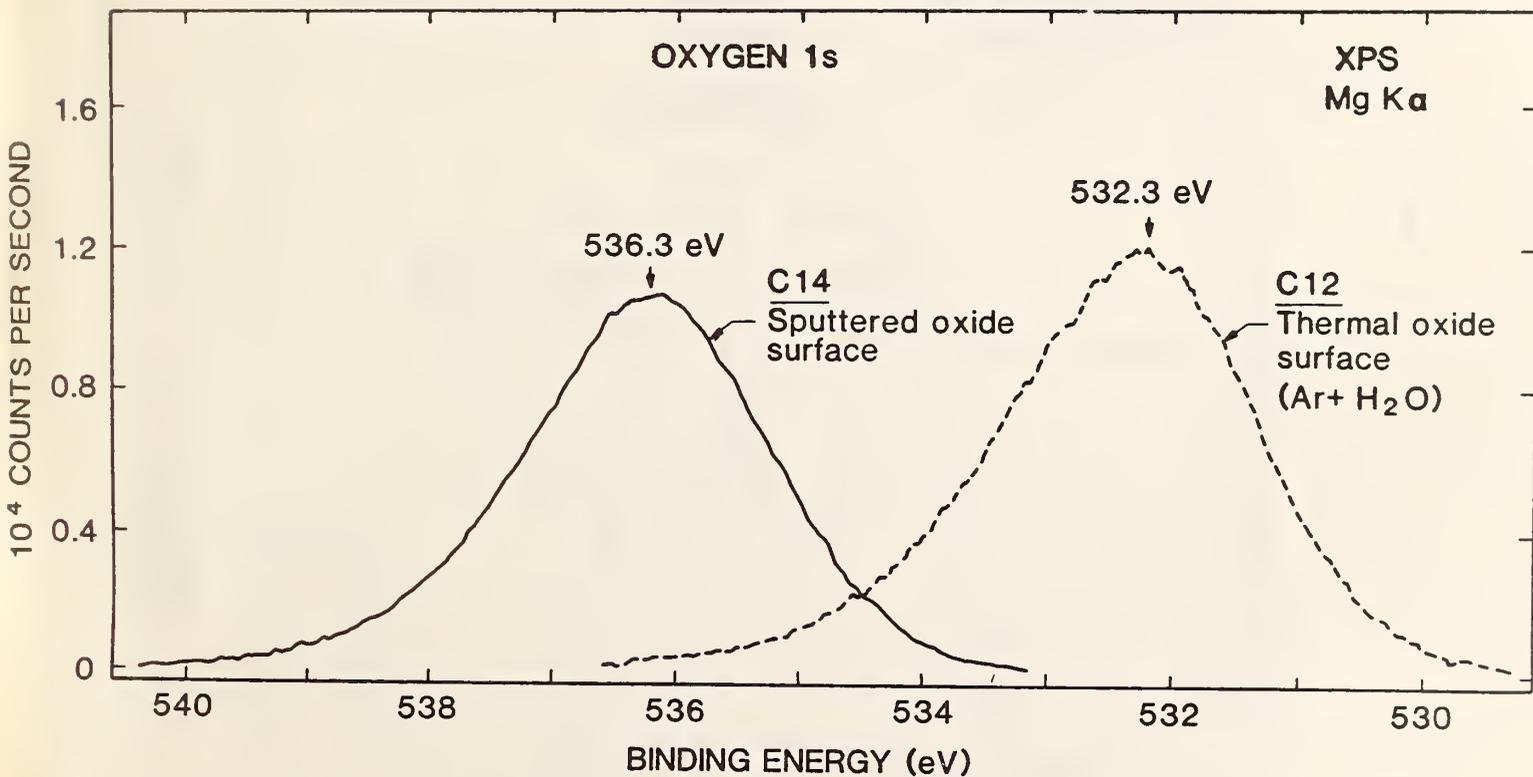
Figure 26. Oxygen 1s XPS core levels from samples C12 and C14. The better insulating properties of the C14 sputtered oxide surface lead to an upward shift in binding energy which positions the O1s level 4eV higher than O1s level from the Ar+H₂O thermal oxide at the surface of C12. Similar shifts were observed in comparisons of other features (e.g., C1s) derived from these samples.

Charging shifts for thermally oxidized samples were always smaller than those observed from sputtered layers of aluminum oxide over a thermal oxide. For example, Figure 26 illustrates an approximately 6 eV shift (mainly from charging since both surfaces are predominantly aluminum oxide) between the oxygen 1s electrons emitted from the sputtered oxide on C14 (2.8 μm sputtered over 2.7 μm thermal) and the Ar+H₂O-grown oxide on C12 (1.1 μm). In this case, the difference in the thicknesses may explain at least part of the larger shift for C14. Charging shifts for air-oxidized samples like A42 [1075°C], B23 [1077°C] and D2 [1025°C] were usually intermediate between the sputtered and Ar+H₂O grown oxides (1.5 eV or more above the Ar+H₂O oxides, and about 1.5 eV below the sputtered overlayer). The charging shift in Figure 27 shows that the air-oxidized D2 (2.7 μm) has a better insulating layer than D1 (Ar+H₂O, 2.6 μm) even though these layers have essentially the same thickness. Notice that there is some difference in the O1s position for the Ar+H₂O oxidized samples C12 [1090°C] and D1 [1050°C] in Figures 26 and 27. This difference, as well as the generally poorer insulating quality of the thermally grown oxides may be connected, not only to differences in oxide thickness, but also to the presence of pores and pits that have been optically observed in such layers. It is possible that the sputtered layers fill these pores, thereby leading to the larger charging shifts that are indicative of better insulating layers.

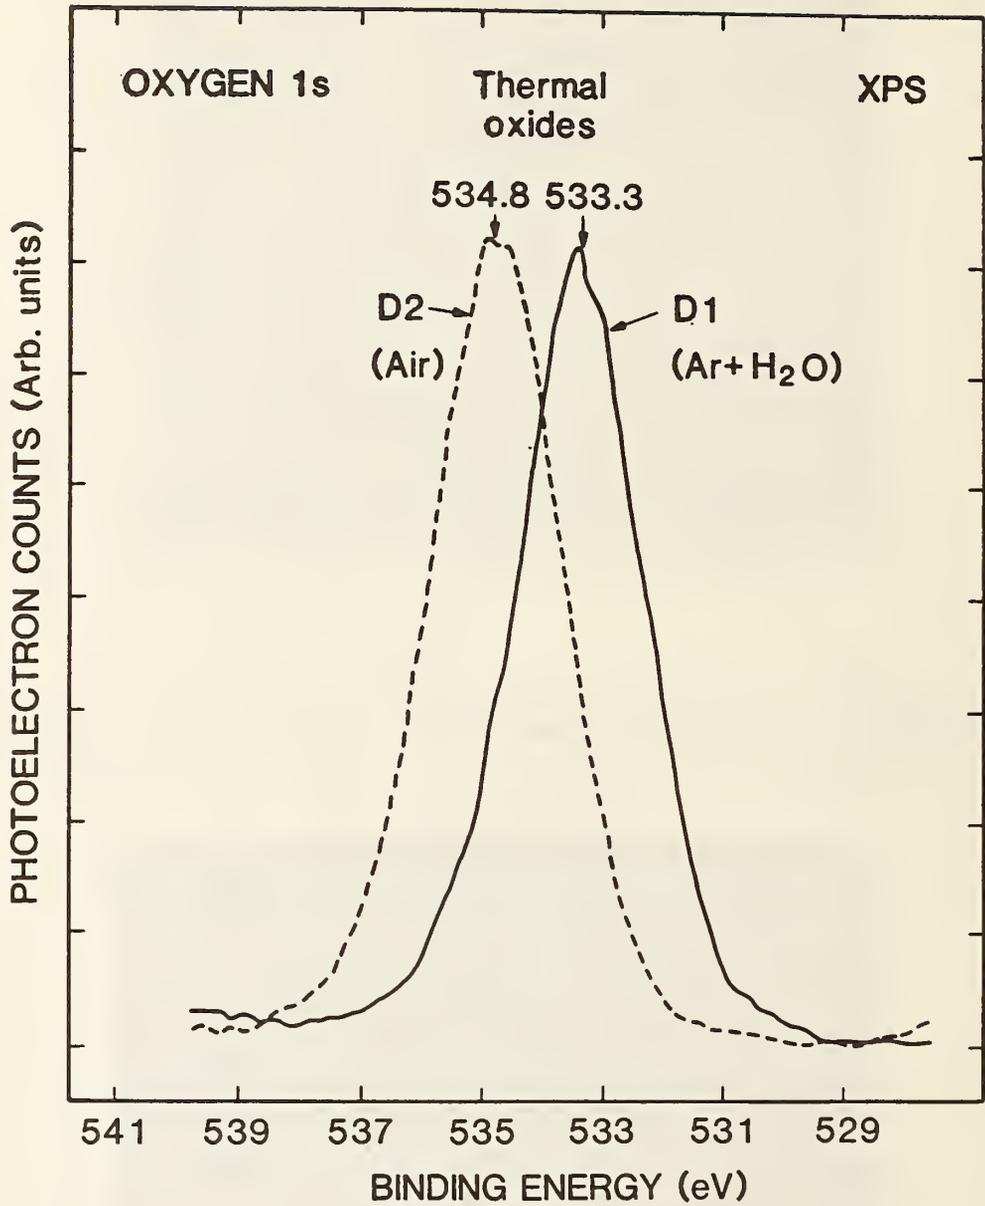
Figure 27. Comparison of the O1s levels for samples D1 and D2. The D2 oxide grown in air has a larger charging shift than the D1 oxide grown in Ar and H₂O. Similar shifts occur between the C1s and other core levels for these samples.

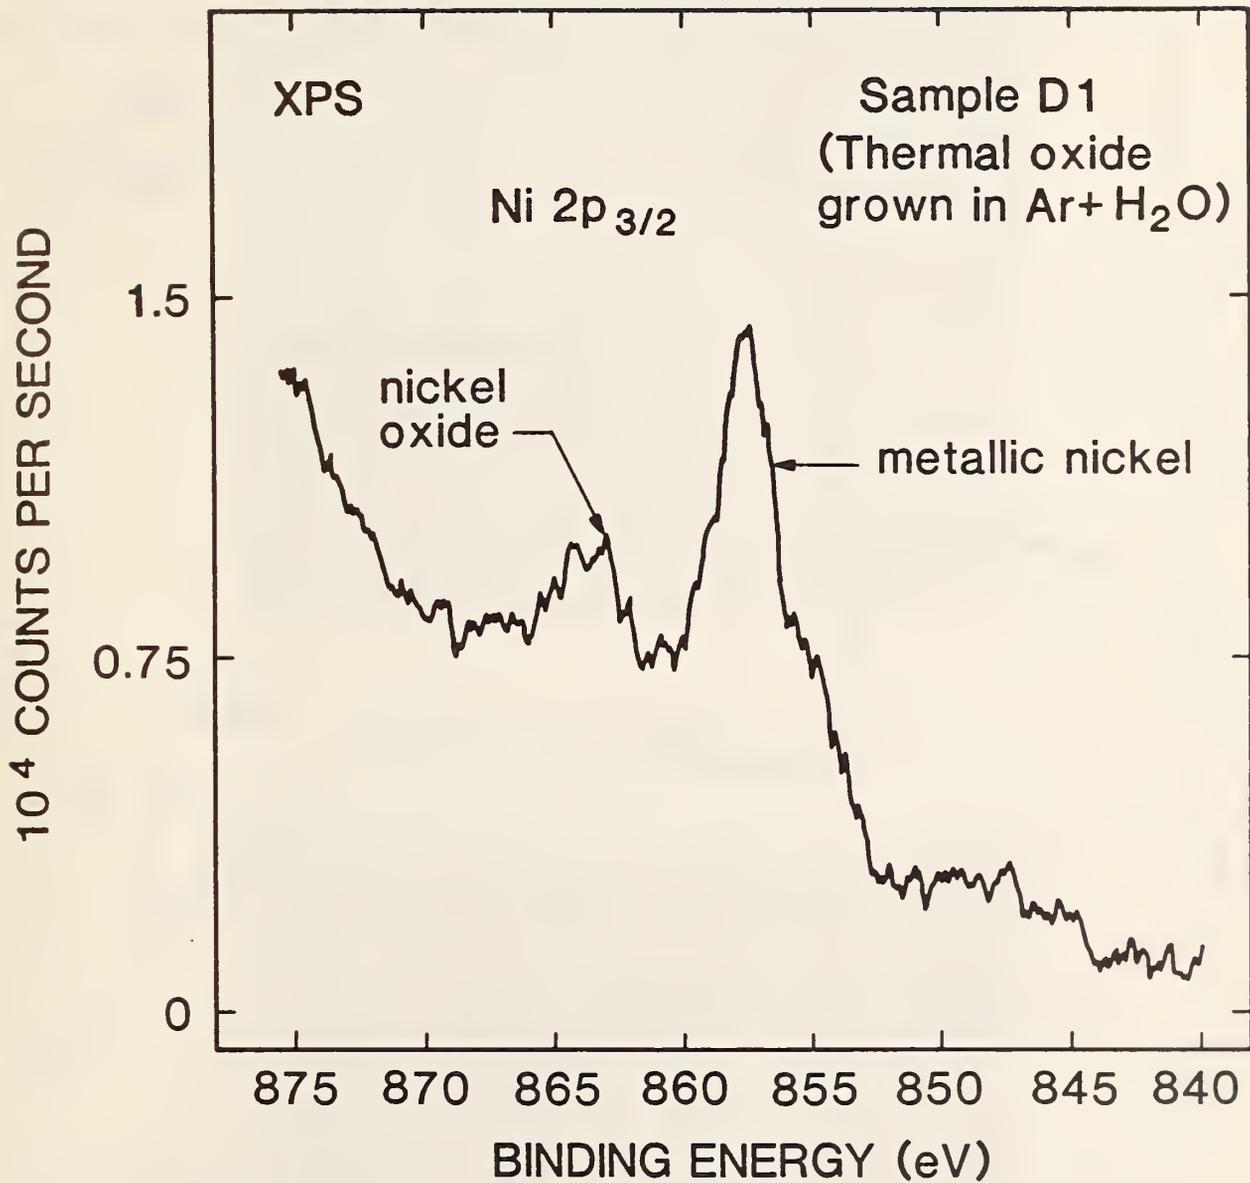
Figure 28. XPS nickel 2p_{3/2} core level region indicating the presence of metallic and oxidized nickel in the surface aluminum oxide of sample D1.

It is interesting to note also that the Ar+H₂O grown oxides may have a somewhat higher Ni and Cr content than their air-grown analogues. Figure 28 shows what is probably the strongest Ni core level signals observed during this study from an aluminum oxide, in this case a Ar+H₂O-grown layer on sample D1. A feature attributable to nickel oxide is also observed several electron volts higher in binding energy. The metallic Ni peak would indicate that the Ni oxidation reaction did not go to completion in the Ar+H₂O atmosphere.

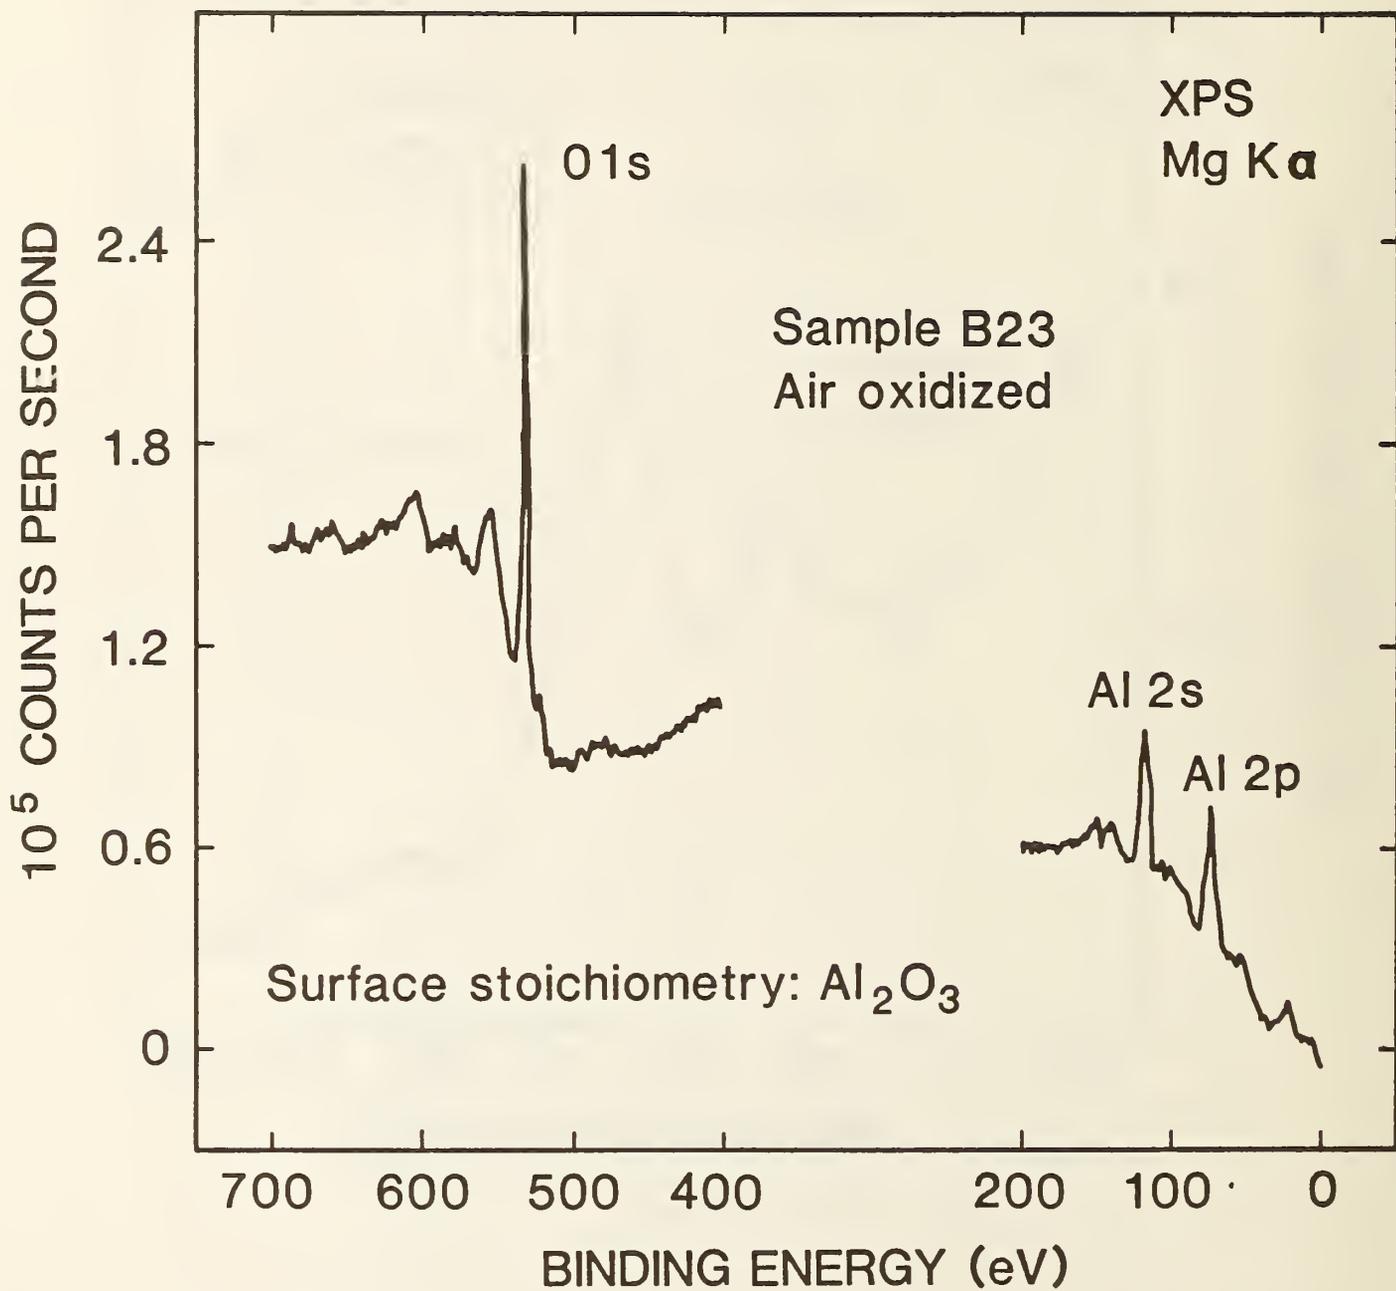
Figure 29. Wide energy range XPS spectrum obtained from the air-oxidized surface of sample B23. The O1s and Al features indicate an Al₂O₃ stoichiometry at the surface.

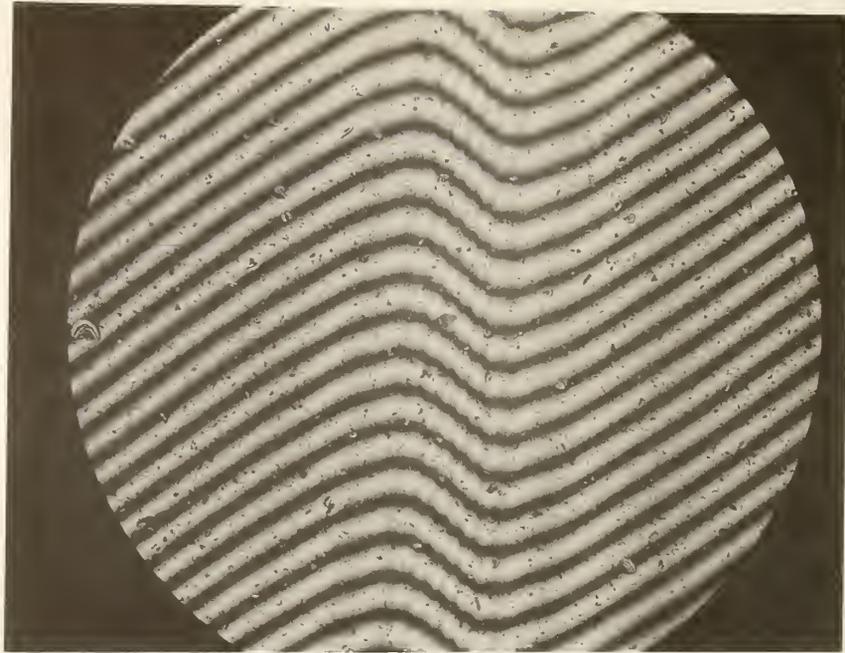
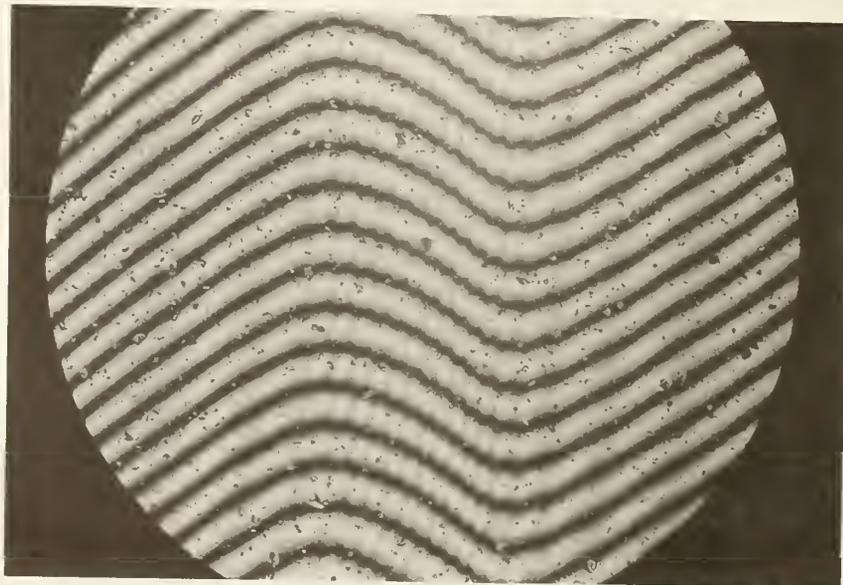
Figure 32. Interferometric micrographs of sputtered aluminum oxide.
Above indicates 1.6 μm thick; below indicates 1.9 μm thick

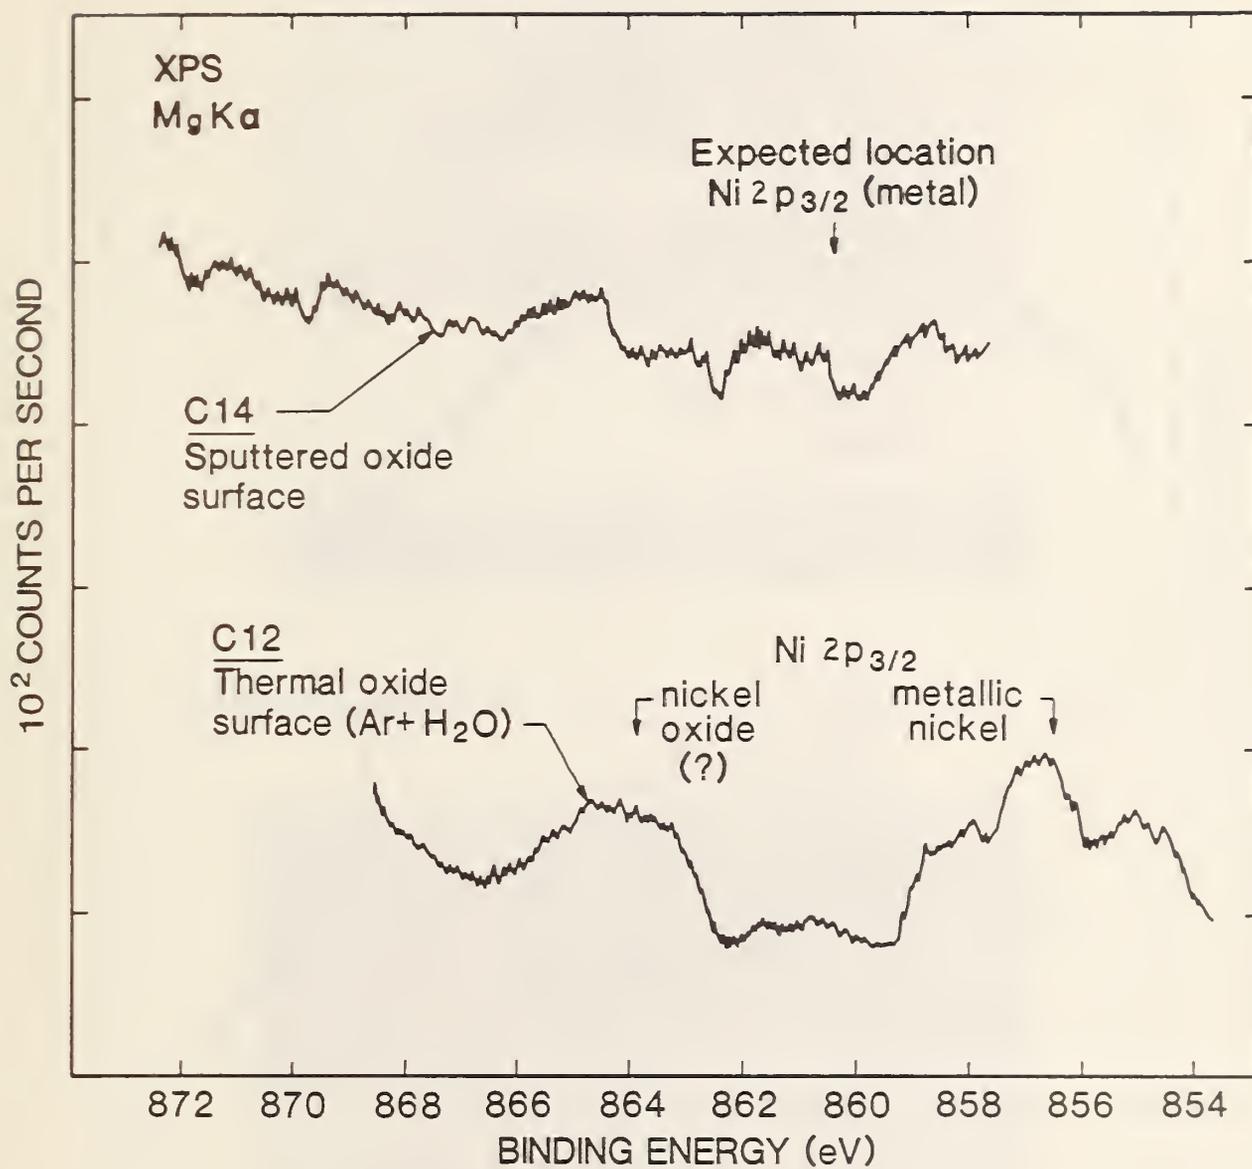
Figure 33. XPS spectra for samples C12 and C14 in the binding energy region near the Ni2p $_{3/2}$ level. The thermally oxidized C12 surface has Ni present at an estimated level near 0.5%, while essentially no Ni is observed in the sputtered aluminum oxide on C14.

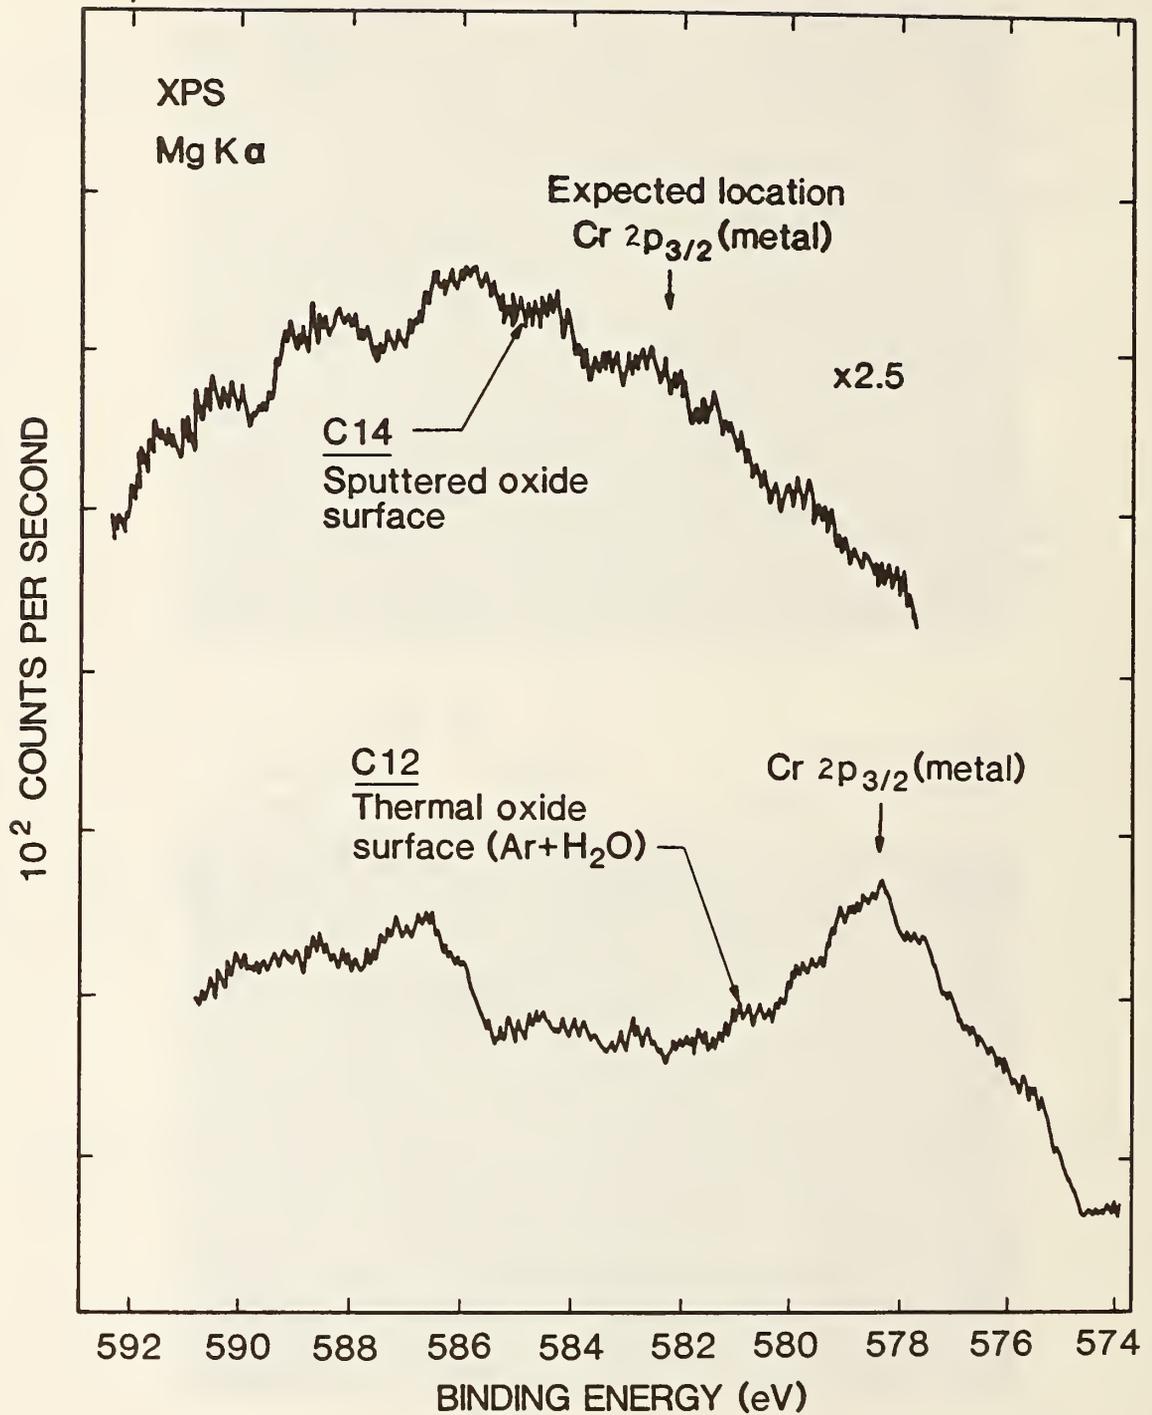
Figure 34. XPS spectra for samples C12 and C14 in the binding energy region near the Cr $2p_{3/2}$ level. The feature in the C12 spectrum indicates a Cr concentration in the thermal oxide near 0.5%, while Cr appears to be completely absent from the sputtered oxide surface of C14.
